Project study of the installation work at the Harbour Walk Haugesund

Betomur deliverables:
Flowpoint grout in black, charcoal grey and red

PROJEKT STUDY

The Harbour Walk in Haugesund
Pointing of cobblestones in pedestrian streets,
harbour areas and traffic areas in the vicinity
of the inner harbour in Haugesund.

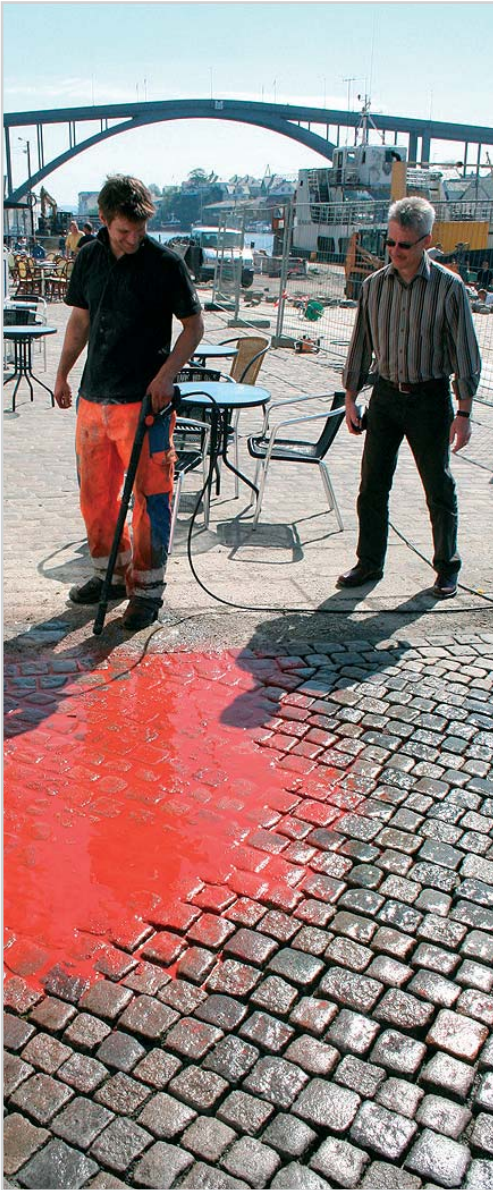
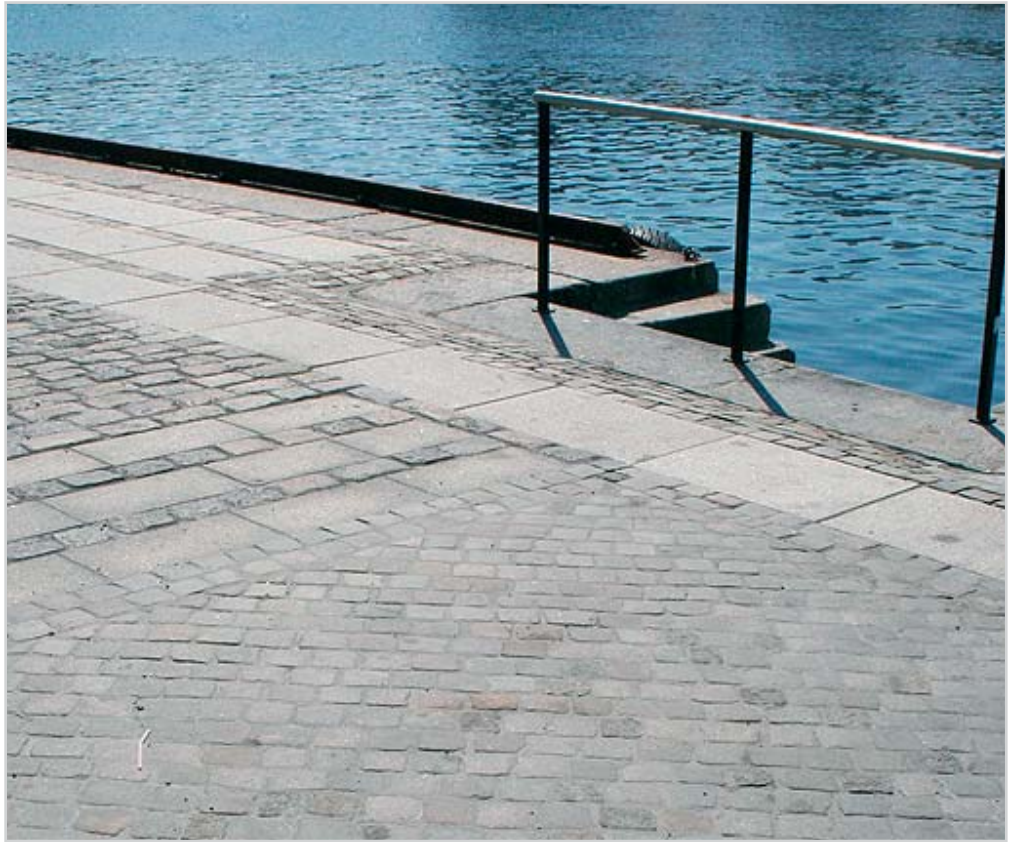
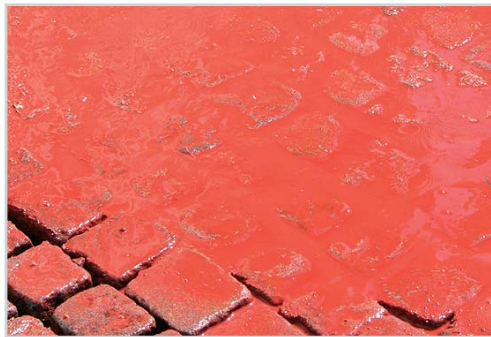
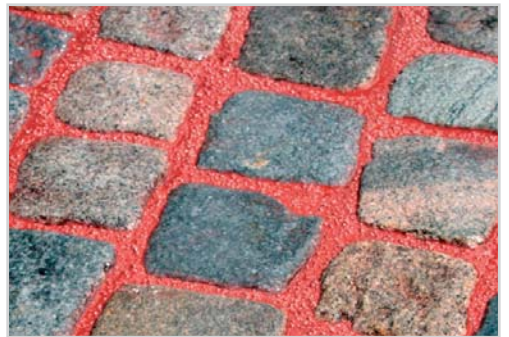
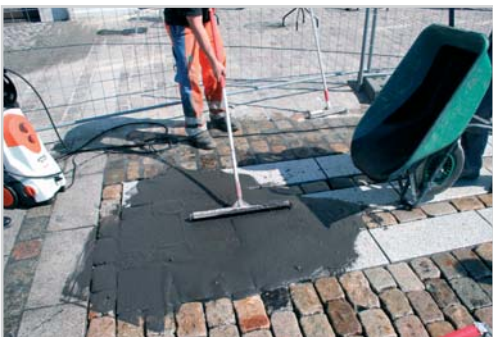
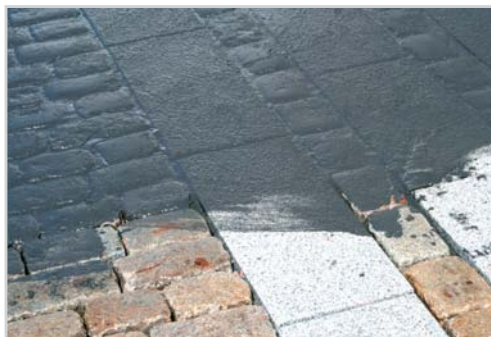
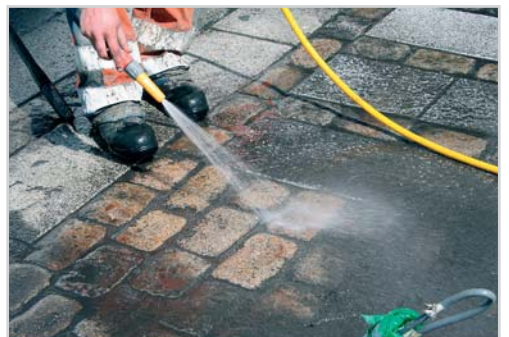
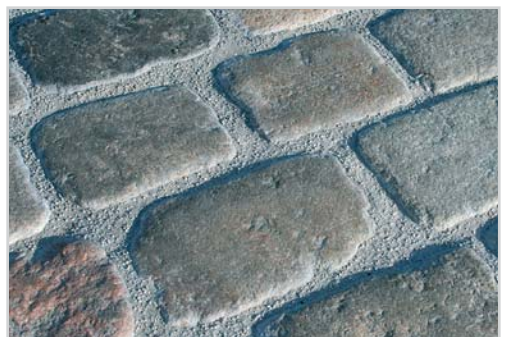
Betomur UltraCrete Flowpoint grout was supplied in red, black and charcoal grey, according to the client's wishes. Photos on Page 4 are from November 2007.

Photos on Page 5 were taken during the construction period and show the grouting process. When dry, the red grout is bleached to provide a warm tone to the natural stone.

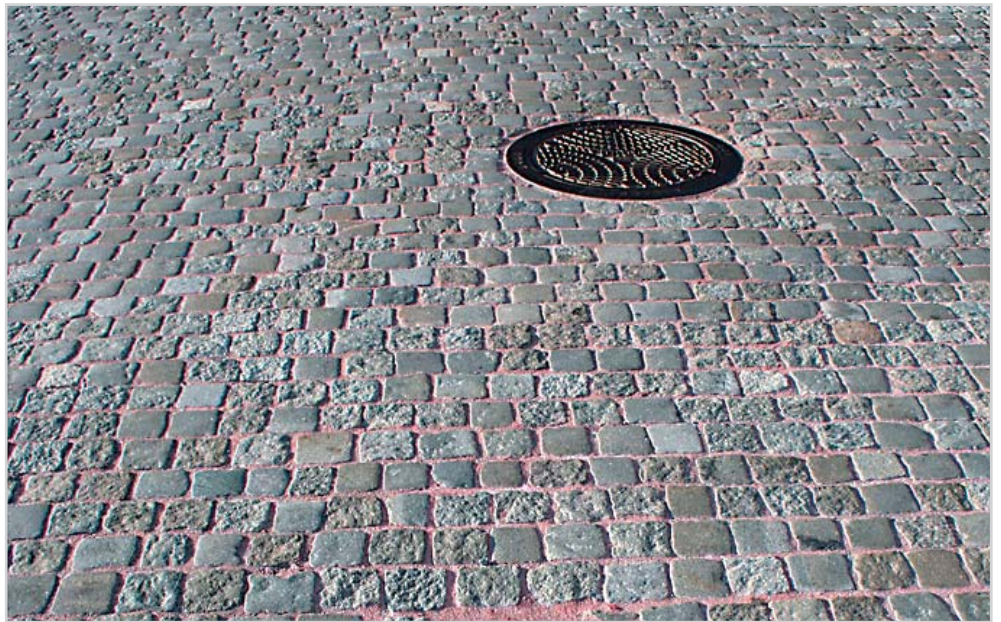
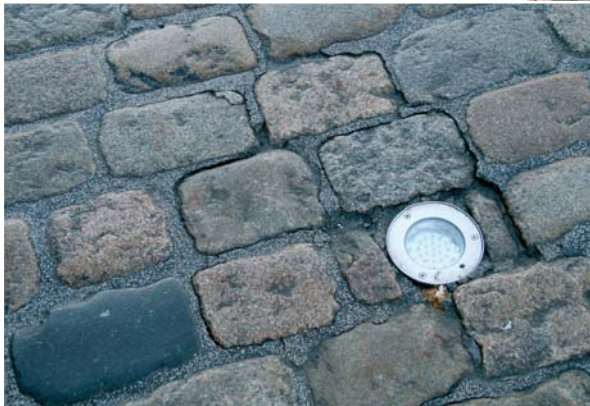
In the first area where installation was commenced, there are a few small flaws caused by settling and unsatisfactory ground work.

Although the paving here has sunk when subjected to heavy loads, the Flowpoint maintains its adhesion to the paving stones. This is evident in that large sheets have subsided, rather than individual stones.

Only two or three small areas in the entire Harbour Walk display such damage. Based on this, the installation must be said to be very successful, and Flowpoint has once again demonstrated its quality.

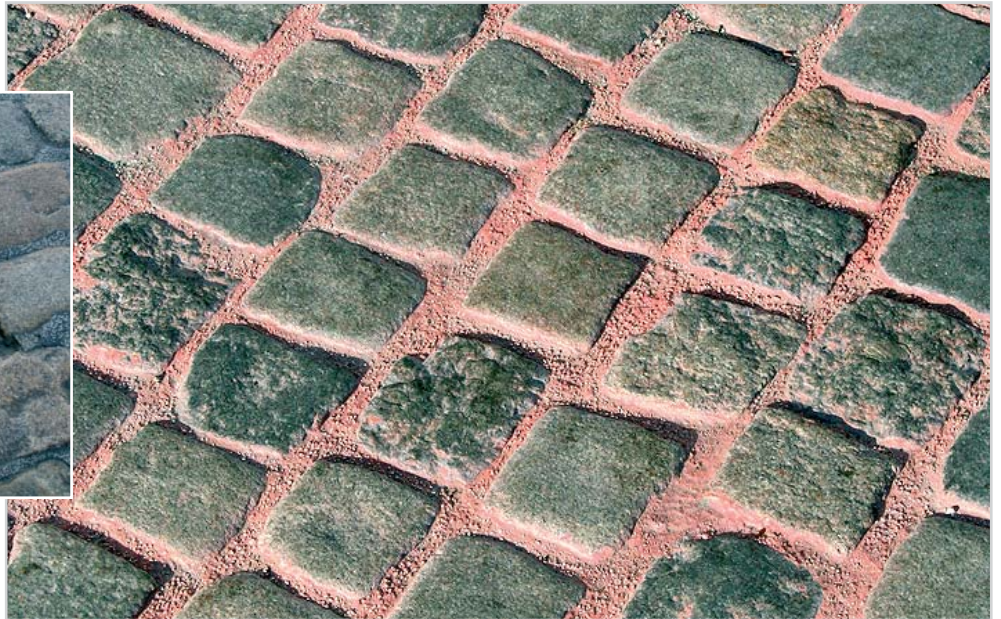
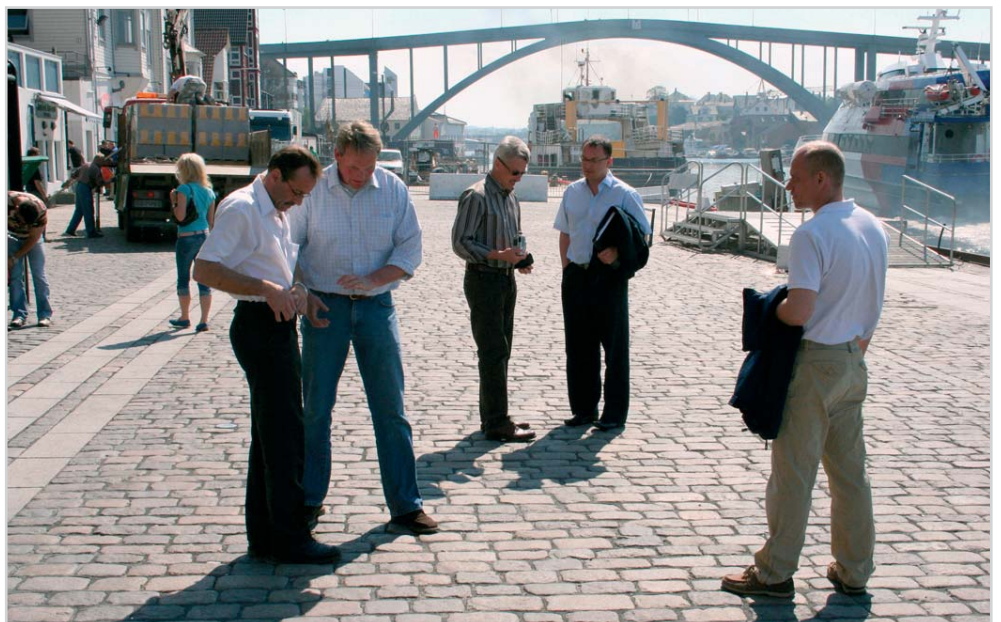
The grouted joints are just as sound after about two years, with no “traps” for stiletto heels, bicycles or prams Street cleaning machines and high-pressure hoses – just bring them on!
